Ipswich River Coastal Bank Stabilization Pilot Project Ipswich, MA

**Task 2 Report
December 27, 2016**

**Prepared by:
Horsley Witten Group, Inc.
Exeter, NH**

**Prepared for:
Alicia Geilen
Conservation Agent
Town of Ipswich, MA**

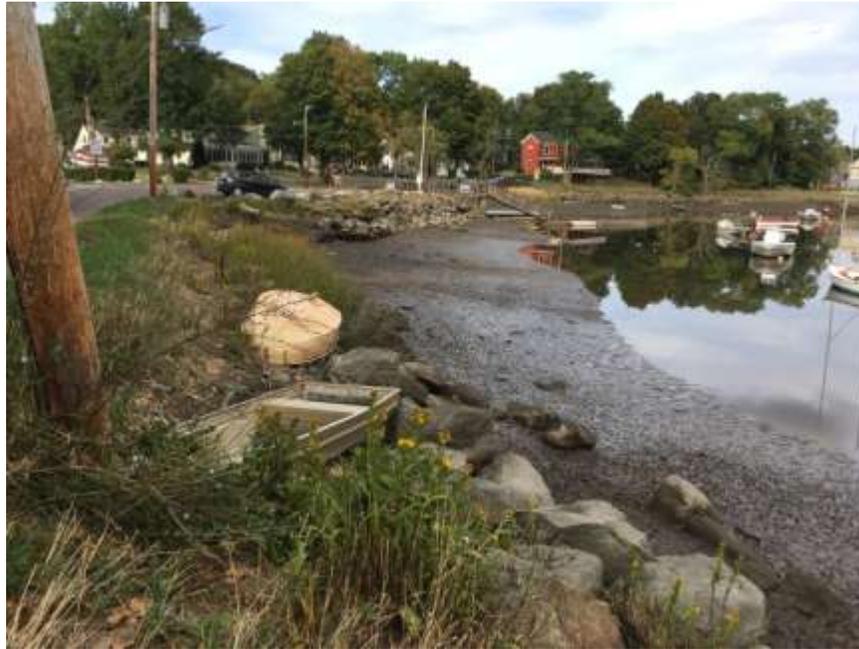
Area of Concern 1A

| Area of Concern | Site Description | Likely Cause of Observed Erosion | Threat to Town Infrastructure? | Threat to Ipswich River Water Quality? | Possibility for public access as part of erosion solution? | Other Notes |
|---|--|---|--|--|--|---|
| 1A | This site is located just west of the boat docks and boat ramp. The bank is eroding, likely due to a combination of some unmanaged stormwater but mainly pedestrian and non-motorized boater access to the river. The bank from the edge of the road is a steep drop of approximately 1-3 feet, down to a riparian marsh along the river. | <p>Pedestrian access to the river and transport and storage of small boats (canoes/kayaks), which is trampling the bank.</p> <p>Uncontrolled stormwater draining off Water Street into the River.</p> | <p>The pavement along the southern edge (river side) of Water Street is eroding due to unmanaged stormwater.</p> <p>There are overhead utilities located along the bank that could be threatened over the long term.</p> | The loss of salt marsh habitat and upland vegetation, and the erosion of the bank are potentially increasing sedimentation into the river. | Possible limited public access for foot traffic and launching of kayaks and canoes may be allowed at this site, given that it is already occurring and habits are difficult to break. Storage of small boats on the bank and wetland resource areas should be prohibited. | |

Bank erosion appears to be caused by unmanaged runoff from Water Street as well as foot traffic and storage of kayaks and small boats on the bank.

| Area of Concern | Recommended Bank Stabilization Technique | HW Recommendations for Public Access | Ipswich Water Access Committee Comments | Notes |
|---|---|---|--|---|
| 1A | <ul style="list-style-type: none"> • Coconut Coir Logs • Living Shoreline, Marsh • Boulder Sill | <p>This site is a potential location for public access, particularly for local neighborhood residents, but public parking is difficult. We note that there was some discussion of opening talks with the adjacent local boat club with regard to public access and upland boat storage and parking.</p> | <p>Current uses:</p> <ul style="list-style-type: none"> • Mooring access • Dinghy tie-up <p>Recommendations:</p> <ul style="list-style-type: none"> • See Area of Concern 1B | <p>The areas of concern along Water Street (A1-A3) will all be similar in nature and will require similar materials. However, each individual site will require specific design for the placement of materials and extent of stabilization required.</p> <p>At this site, the coconut coir log will be used to protect the receding salt marsh. This will also help bring the grade up to be able to establish a living shoreline behind the coir logs. The living shoreline will then transition into the existing salt marsh.</p> |

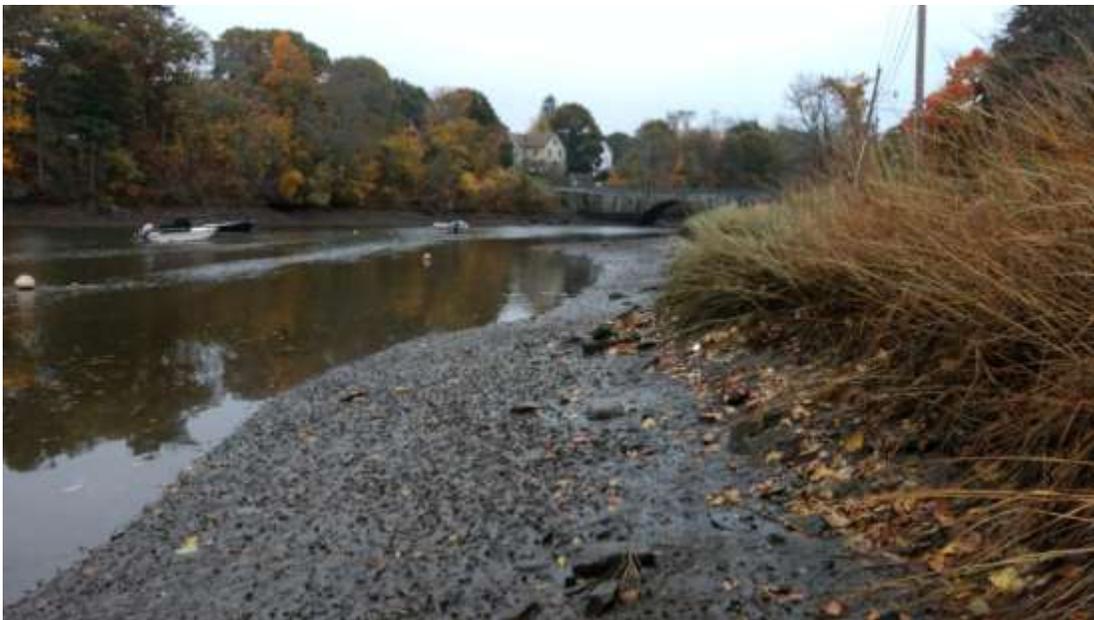
Area of Concern 1B

| Area of Concern | Site Description | Likely Cause of Observed Erosion | Threat to Town Infrastructure? | Threat to Ipswich River Water Quality? | Possibility for public access as part of erosion solution? | Other Notes |
|---|--|---|--|--|--|---|
| 1B | This site is located on Water Street across the street from Summer Street. At the site is a stormwater outfall with a headwall and duckbill check valve installed to prevent backflow into the system. The headwall is failing, and the bank around the headwall, particularly to the west, is heavily eroded, compromising the headwall integrity. The area west of the headwall has been heavily trampled and the existing salt marsh has been degraded. A large mud flat extends into the river in this area. | <p>Pedestrian access to the river and transport and storage of small boats (canoes/kayaks), which is trampling the bank.</p> <p>The toe of the bank is being undercut by the river flow.</p> <p>Stormwater draining off Water Street into the River instead of being captured by the existing underground stormwater collection and treatment (catch basins and Stormceptor). The runoff from the road appears to bypass the drainage infrastructure and flow over the bank into the river.</p> | <p>The existing stormwater outfall structure and adjacent pavement on Water Street are heavily eroding due to stormwater runoff, foot traffic and boat storage at the site. This will continue to worsen if it is not addressed.</p> <p>There are overhead utilities located along the bank that could be threatened over the long term.</p> | <p>The stormwater that bypasses the drainage system and the Stormceptor is receiving no treatment prior to reaching the river.</p> <p>The loss of salt marsh habitat and upland vegetation, and the erosion of the bank are potentially increasing sedimentation into the river.</p> | Possible limited public access for foot traffic and launching of kayaks and canoes may be allowed at this site, given that it is already occurring and habits are difficult to break. However, storage of small boats on the bank and wetland resource areas should be prohibited. | Entire length of bank along Water Street between AOC 1A and 1C. The bank is eroding and unstable in various locations. The bank is steeper and taller at the AOC 1C end and gets continually lower and less steep toward AOC 1A. The bank between AOCs 1B and 1C includes boulders that have begun to shift and fall out of the bank. The bank between AOCs 1A and 1B is much shallower and includes sections of salt marsh extending up to the paved road. |

Similar to site 1A, stormwater runoff from the adjacent street and trampling by pedestrians are contributing to the erosion, but the bank is also being undercut by the river, likely due to elevated flow velocity.

| Area of Concern | Recommended Bank Stabilization Technique | HW Recommendations for Public Access | Ipswich Water Access Committee Comments | Notes |
|---|---|---|--|---|
| 1B | <ul style="list-style-type: none"> • Coconut Coir Logs • Living Shoreline, Marsh • Boulder Sill | <p>This site is a potential location for public access, particularly for local neighborhood residents, but public parking is difficult. We note that there was some discussion of opening talks with the adjacent local boat club with regard to public access and upland boat storage and parking.</p> | <p>Current uses:</p> <ul style="list-style-type: none"> • Mooring access • Dinghy tie-up • Non-motorize boat launch/haul • Boat passenger drop off • Swimming/wading • Dog swimming • Fishing access <p>Recommendations:</p> <ul style="list-style-type: none"> • Combine all uses for 1 A,B,C into one defined area in the location of 1B • Use permits to control dinghy tie up, consolidate to 1B location | <p>The areas of concern along Water Street (A1-A3) will all be similar in nature and will require similar materials. However, each individual site will require specific design for the placement of materials and extent of stabilization required.</p> <p>At this site, the coconut coir log will be used to protect the receding salt marsh. This will also help bring the grade up to be able to establish a living shoreline behind the coir logs. The living shoreline will then transition into the existing salt marsh. We will work around any retrofit to the existing stormwater outfall and headwall.</p> |

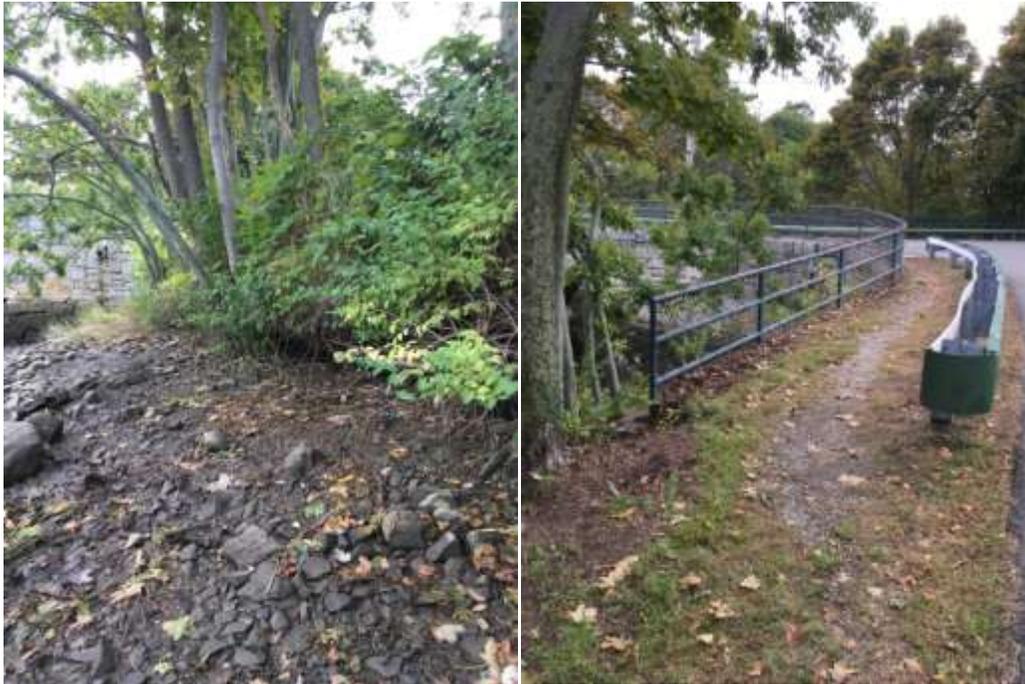
Area of Concern 1C

| Area of Concern | Site Description | Likely Cause of Observed Erosion | Threat to Town Infrastructure? | Threat to Ipswich River Water Quality? | Possibility for public access as part of erosion solution? | Other Notes |
|---|--|---|--|--|--|---|
| 1C | This site is located on Water Street just downstream of the Green St. bridge. The bank in this location is taller and steeper than further downstream, because of the bridge abutment and associated embankment. Erosion in this area appears to be occurring at various locations where road runoff flows unmanaged over the bank. Some undercutting erosion is occurring at the toe of the bank as well. | Stormwater draining off Water Street into the River instead of being captured by the existing underground stormwater collection and treatment (catch basins and Stormceptor). The runoff from the road appears to bypass the drainage infrastructure and flow over the bank into the river. | <p>The pavement along the southern edge (river side) of Water Street is eroding due to unmanaged stormwater.</p> <p>There are overhead utilities located along the bank that could be threatened over the long term.</p> | The stormwater that bypasses the drainage system and the Stormceptor is receiving no treatment prior to reaching the river. | No public access is appropriate at this site due to the steep tall banks. No public access appears to be taking place under current conditions. | |

The bank at this location just downstream of the Green Street bridge is being undercut by the flow in the river. In addition, stormwater runoff from both Green Street and Water Street is flowing uncontrolled off the pavement and down the bank next to the tree in the picture on the right above.

| Area of Concern | Recommended Bank Stabilization Technique | HW Recommendations for Public Access | Ipswich Water Access Committee Comments | Notes |
|---|---|---|--|---|
| 1C | <ul style="list-style-type: none"> • Coconut Coir Logs • Living Shoreline, Marsh | <p>This is not an area that is recommended to have public access. The existing slope will be too steep to have any safe way to access the coastal bank.</p> | <p>Current uses:</p> <ul style="list-style-type: none"> • Boat passenger drop off • Swimming/Wading <p>Recommendations:</p> <ul style="list-style-type: none"> • See Area of Concern 1B | <p>In this area, the coir log will be used to fill in and stabilize the undercutting at the toe of the bank at the high water elevation.</p> |

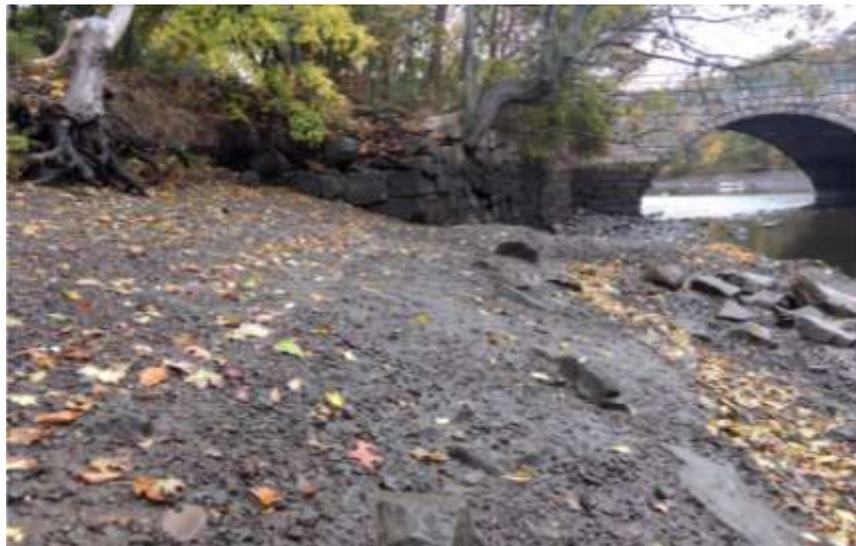
Area of Concern 2

| Area of Concern | Site Description | Likely Cause of Observed Erosion | Threat to Town Infrastructure? | Threat to Ipswich River Water Quality? | Possibility for public access as part of erosion solution? | Other Notes |
|---|---|--|--|--|---|---|
| 2 | <p>This site is just upstream from the Green St. bridge and just upstream from an old bridge abutment constructed of granite blocks that still stands over 10 feet tall. Approximately 35-40 feet of the bank has eroded into the river, depositing sediment and boulders into the riverbed just in front of the site. The bank is quiet unstable and drops down vertically by 2-3 feet from the walking path. This appears to be a high traffic area for pedestrians accessing the river, but it is unclear if people are using this site as a put in for non-motorized boats.</p> | <p>Erosion at this site appears to be caused by a combination of factors:</p> <p>Heavy use by pedestrians accessing the river has damaged the embankment.</p> <p>Flow in the river appears to be causing erosion at this location, and is likely exacerbated by the adjacent manmade structures. The downstream edge is defined by a tall remnant bridge abutment wall and the upstream edge is defined by large boulder revetment that was installed sometime in the last century, possibly related to the sewer installation in the 1960s.</p> | <p>There is a notable threat to the sewer infrastructure at this site. The sewer trunk line is underground within the walking path and likely very close to the eroding edge of the bank.</p> | <p>There is a significant threat to the sewer infrastructure at this site. The sewer trunk line in this area is old, based on the 1956 design plans, and any failure could result in a direct discharge of sewage to the river.</p> | <p>This site was favored for public access for canoe/kayak launch, wading, dog access, and viewing during discussions at the site walk, because of the proximity to public parking and the relatively large site (30-40 feet long) that is being addressed. The river is also somewhat shallow at this location because of all of the material that has eroded from the bank into the river channel. However, a put-in just upstream of a large bridge structure can pose some safety hazards, especially when the river flows are normal or heavier than normal.</p> | <p>The area that is eroding was originally constructed and filled for the purpose of cover and bank stabilization for the installation of the sewer line. The sewer line was actually installed within the river and the river was filled and narrowed.</p> |

Scour from existing bridge abutment is contributing to the bank eroding down into the river, leaving a large sediment deposit in the river and exposing roots of trees along the bank. This site is also being used as an access point to the river by pedestrians for viewing the river. No visible evidence of boat access at this time, but the Town is interested in exploring potential canoe/kayak access at this location.

| Area of Concern | Recommended Bank Stabilization Technique | HW Recommendations for Public Access | Ipswich Water Access Committee Comments | Notes |
|---|---|---|--|---|
| 2 | <ul style="list-style-type: none"> • Coconut Coir Logs • Revetment (Boulder, Log, Rootwad, Tree) • Boulder Sill • Living Shoreline, Marsh | <p>This area is not recommended to have public access. This area is of such concern to stabilize and to possibly incorporate a living shoreline that to provide access to the public may interfere with the proposed methods. However, we note that public parking is very convenient to this location, making it an attractive option.</p> | <p>Current uses:</p> <ul style="list-style-type: none"> • Limited dog swimming • Not much other use due to condition of the bank | <p>This is an area that will need to be addressed with a stabilization technique. It is experiencing significant scour, likely as the incoming tide passes the existing retaining wall/old bridge abutment wall that extends upstream from the Green Street bridge. Boulder sills will reduce the scour by decreasing the force on the riverbank.</p> |

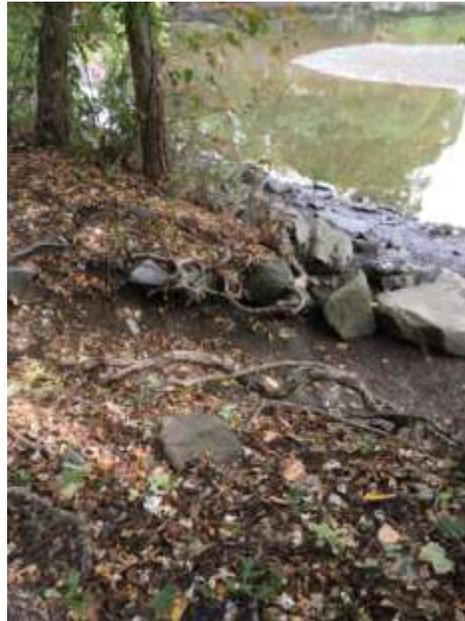
Area of Concern 3

| Area of Concern | Site Description | Likely Cause of Observed Erosion | Threat to Town Infrastructure? | Threat to Ipswich River Water Quality? | Possibility for public access as part of erosion solution? | Other Notes |
|---|---|--|--|--|---|---|
| 3 | <p>This site is about halfway between Green St and County Rd. It is clearly used as an access point to the river, and has been heavily altered by pedestrian access. A clear path extends from the walking path down to the river, lined on both sides by exposed tree roots around which the sediment has been long eroded away. This site is the inside of a curve in the river, and there is a significant amount of deposition occurring in front of this area, creating a large shallow mud flat feature in the river.</p> | <p>Erosion at this site appears to be caused almost entirely by pedestrian access to the river, which is quite shallow in this area. It is not readily clear if people bring non-motorized boats to this location to put in.</p> <p>There may be some limited stormwater runoff from the ball fields behind Town Hall that is contributing to the bank erosion at this location and in the surrounding areas.</p> | <p>There is a sewer trunk line within the adjacent walking path along the Ipswich River in this area, but the erosion at this site does not appear to pose any imminent threat to that line due to the separation distance from that line.</p> | <p>There does not appear to be a significant threat to water quality.</p> | <p>This site would be a potential candidate for public access for wading, dog access, fishing, and viewing, in particular because the bank slope is relatively shallow at this point and the river itself is quite shallow due to significant deposition in front of the site.</p> | |

The observed erosion at this site appears to be caused by a combination of stormwater runoff from the adjacent upland area, and pedestrian traffic down to the river and mud flat area that has formed on this shore of the river.

| Area of Concern | Recommended Bank Stabilization Technique | HW Recommendations for Public Access | Ipswich Water Access Committee Comments | Notes |
|---|---|---|--|---|
| 3 | <ul style="list-style-type: none"> • Coconut Coir Logs • Brush Mattress and Live Stakes | <p>We recommended this site for continued public access. This site clearly has an established use as a public access, and could be adapted to provide small-boat put-in access.</p> | <p>Current uses:</p> <ul style="list-style-type: none"> • Dog Swimming • Wading • Fishing | <p>This is a small area that would not require significant effort to manage, if the coir logs are installed correctly and remain in place.</p> |

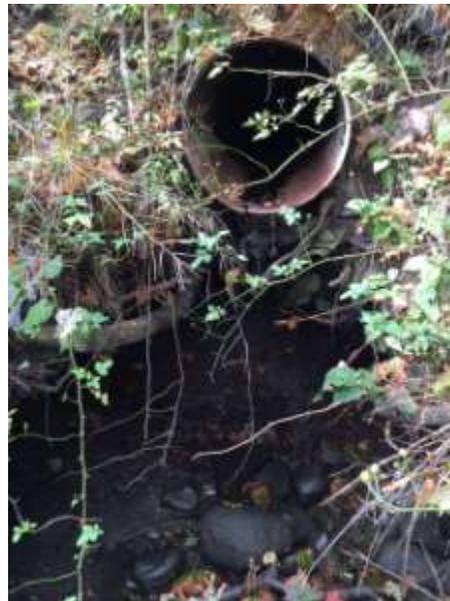
Area of Concern 4

| Area of Concern | Site Description | Likely Cause of Observed Erosion | Threat to Town Infrastructure? | Threat to Ipswich River Water Quality? | Possibility for public access as part of erosion solution? | Other Notes |
|---|---|--|--|--|---|---|
| 4 | | | <p>This site threatens the stability of the bank that contains the rusted out stormwater drain pipe. The drain pipe needs to be replaced.</p> | <p>The stormwater pipe is causing significant erosion and incising of the bank, which is delivering excess sediment into the channel. It is unclear if the stormwater is being pretreated prior to discharge, but this site may present an opportunity to retrofit the stormwater infrastructure for treatment</p> | <p>Public access to the water is not appropriate at this site because of the high steep slope.</p> | |

The outlet end of an old corrugated metal stormwater pipe from County Road has disintegrated, allowing water to drain directly out of the bottom of the last several feet of the pipe. As a result, the bank is severely undercut under the pipe and the edge of the cut is receding.

| Area of Concern | Recommended Bank Stabilization Technique | HW Recommendations for Public Access | Ipswich Water Access Committee Comments | Notes |
|---|---|---|---|---|
| 4 | <ul style="list-style-type: none"> • Coconut Coir Logs • Living Shoreline • Brush Mattress and Live Stakes | This area is not recommended to have public access. | Current uses: <ul style="list-style-type: none"> • Dog swimming • Wading • Fishing | |

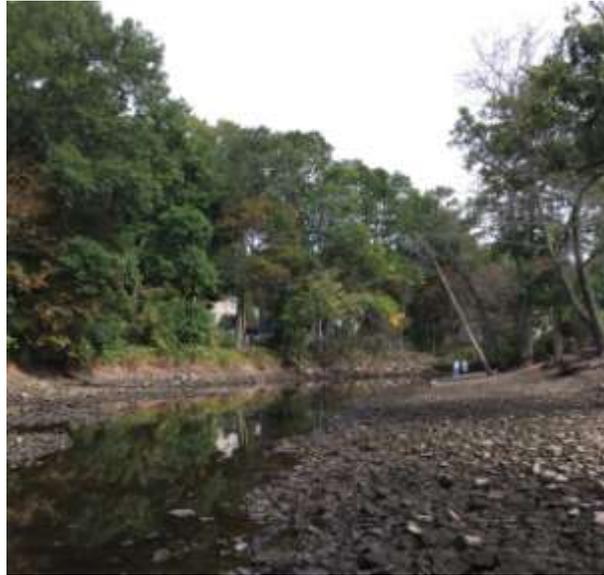
Area of Concern 5A

| Area of Concern | Site Description | Likely Cause of Observed Erosion | Threat to Town Infrastructure? | Threat to Ipswich River Water Quality? | Possibility for public access as part of erosion solution? | Other Notes |
|---|---|--|--|--|---|---|
| 5A | A sewer siphon that crosses the Ipswich River downstream of the S. Main St. bridge is now exposed in the riverbed. The soil cover that once protected the siphon has been washed away. | Erosion is likely caused by high velocity flows, either during large storm events or in combination with long-term exposure to higher flows, potentially exacerbated by increased development in the watershed or increasing frequency of high-intensity storm events. | There is a significant threat to the sewer infrastructure at this site. The pipes that were observed are old and likely in need to repair or replacement. | The water quality threat at this site originates from the threat of the sewer infrastructure failing, which would cause a wastewater discharge into the river. | Public access for canoe/kayak put-in is not appropriate at this site. | This exposed siphon was observed during the site visits related to this project during a long period of severe drought and very low flow conditions. The level of stabilization, protection, evaluation, and restoration of the sewer infrastructure likely makes this project significantly broader than the scope of the CZM grant, and likely more significant in cost. |

The sewer siphon has been exposed within the riverbed where it was originally buried. It crosses from the southern side of the river to the northern side, where it connects to the main sewer trunk line at a manhole in a residential back yard on the north side of the river.

| Area of Concern | Recommended Bank Stabilization Technique | HW Recommendations for Public Access | Ipswich Water Access Committee Comments | Notes |
|---|---|---|---|---|
| 5A | <ul style="list-style-type: none"> • Revetment (Boulders, Logs, Rootwads, Trees) | This area is not recommended to have public access. | Current uses: <ul style="list-style-type: none"> • Dog Swimming | Due to the age of the sewer line, this site might require replacement of the sewer infrastructure, making this a much larger undertaking than is anticipated from this grant. |

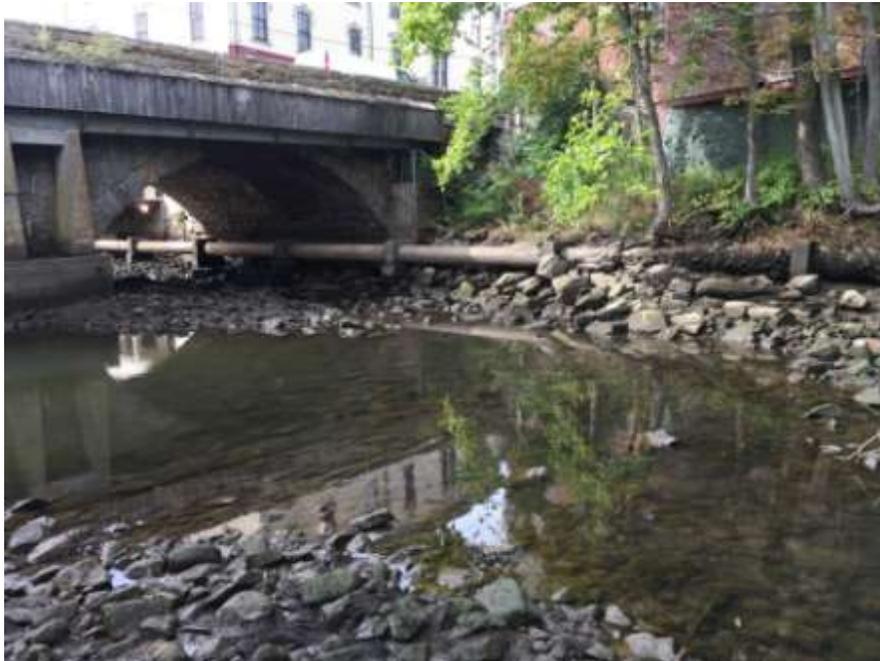
Area of Concern 5B

| Area of Concern | Site Description | Likely Cause of Observed Erosion | Threat to Town Infrastructure? | Threat to Ipswich River Water Quality? | Possibility for public access as part of erosion solution? | Other Notes |
|---|---|--|--|--|---|---|
| 5B | A sewer trunk line that runs parallel to the river on the north side of the river in the vicinity of and underneath the S. Main St. bridge is fully exposed. It appears that portions of it were originally installed under soil cover for protection, while other portions were purposefully installed above the riverbank. The protective soil cover along the downstream segment of this pipe has been eroded away, exposing the sewer to the river environment. | Erosion is likely caused by high velocity flows, either during large storm events or in combination with long-term exposure to higher flows, potentially exacerbated by increased development in the watershed or increasing frequency of high-intensity storm events. | There is a significant threat to the sewer infrastructure at this site. The pipes that were observed are old and likely in need to repair or replacement. | The water quality threat at this site originates from the threat of the sewer infrastructure failing, which would cause a wastewater discharge into the river. | Public access for canoe/kayak is not appropriate at this site. | The level of stabilization, protection, evaluation, and restoration of the sewer infrastructure likely makes this project significantly broader than the scope of the CZM grant, and likely more significant in cost. |

Transition from where exposed sewer pipe travels underground, losing ground cover between bank and top of pipe.

| Area of Concern | Recommended Bank Stabilization Technique | HW Recommendations for Public Access | Ipswich Water Access Committee Comments | Notes |
|---|---|---|---|---|
| 5B | <ul style="list-style-type: none"> • Revetment (Boulders, Logs, Rootwads, Trees) | This area is not recommended to have public access. | Current uses: <ul style="list-style-type: none"> • No activity noted | Due to the age of the sewer line, this site might require replacement of the sewer infrastructure, making this a much larger undertaking than is anticipated from this grant. |

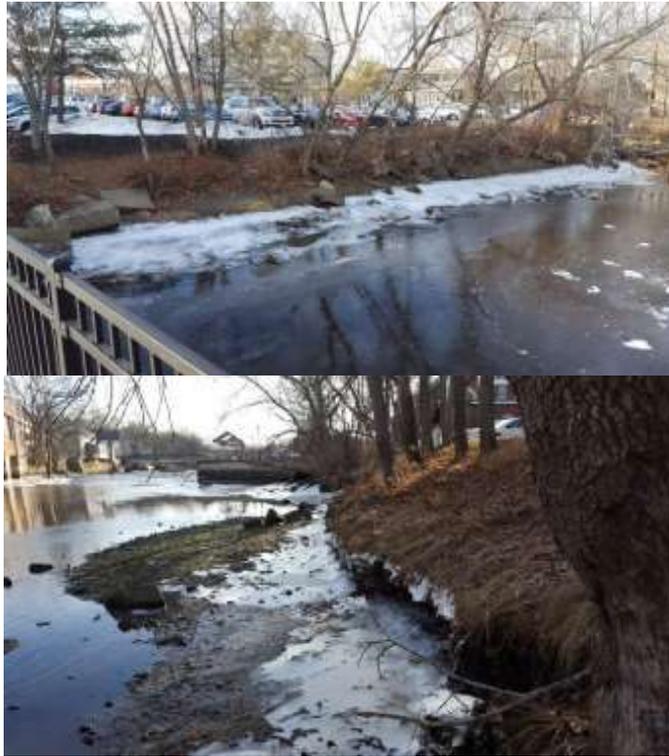
Area of Concern 6

| Area of Concern | Site Description | Likely Cause of Observed Erosion | Threat to Town Infrastructure? | Threat to Ipswich River Water Quality? | Possibility for public access as part of erosion solution? | Other Notes |
|---|---|--|--|--|---|---|
| 6 | The riverbank is undercut at the back edge of the parking lots serving the Market Street businesses, beginning at the Riverwalk at the EBSCO property and extending approximately 200 feet downstream toward the Choate Bridge. The Farley Brook outfall also discharges in this area. | Flow in the river appears to be causing erosion at this location, which is the outer edge of a significant bend in the river. It is likely exacerbated by flows passing the EBSCO parking lot and the Riverwalk located just upstream of this site. | The parking areas serving the Market Street businesses are located at the top of the bank. Further erosion could eventually threaten the back edge of the parking lot. In addition, the Farley Brook outfall structure could be compromised by additional erosion. | There does not appear to be a significant threat to water quality. | Public access down to the river for canoe/kayak put-in or wading/fishing is not appropriate near the Farley Brook outfall pipe. The Riverwalk is currently located upstream of this site. | |

The eroded riverbank extends approximately 200 feet downstream from the Riverwalk at the EBSCO property, along the back side of the parking areas serving the Market Street businesses. The photos above show the erosion at low tide, looking downstream from the Riverwalk toward the Farley Brook outfall (top photo) and upstream toward the Farley Brook outfall (bottom photo).

| Area of Concern | Recommended Bank Stabilization Technique | HW Recommendations for Public Access | Ipswich Water Access Committee Comments | Notes |
|---|---|---|---|---|
| 6 | <ul style="list-style-type: none"> • Coconut Coir Logs • Boulder Sill • Living Shoreline • Brush Mattress and Live Stakes | This area is not recommended to have public access to the water. Any contemplated extension of the Riverwalk should be above the top of bank. | This site was not discussed. | |
