IPSWICH RIVER COASTAL BANK STABILIZATION PILOT PROJECT

Prepared for: THE TOWN OF IPSWICH

TASK 3 REPORT

February 21, 2017

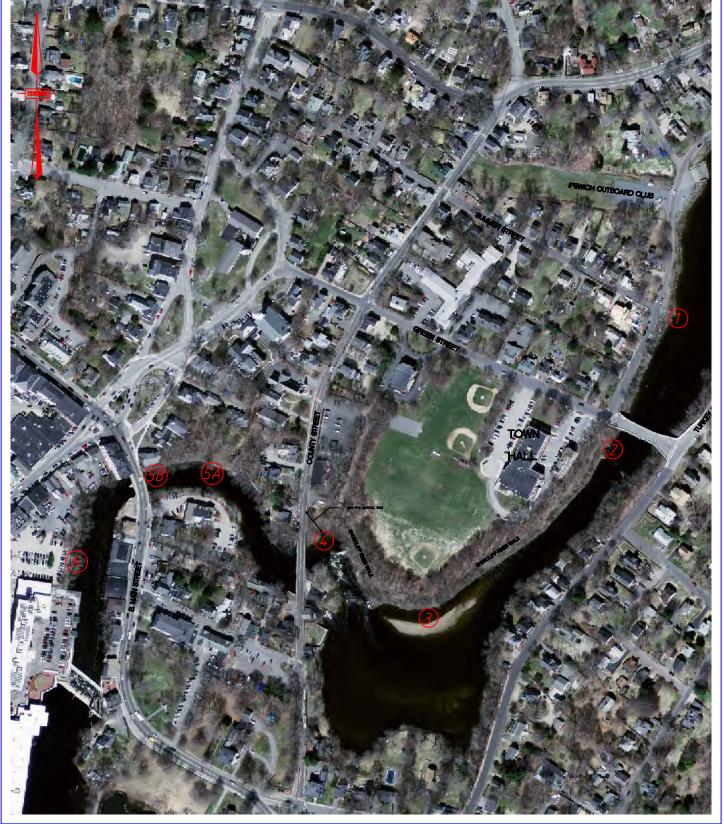
Coastal Resiliency & Coastal Bank Stabilization Pilot Project - Areas of Concern

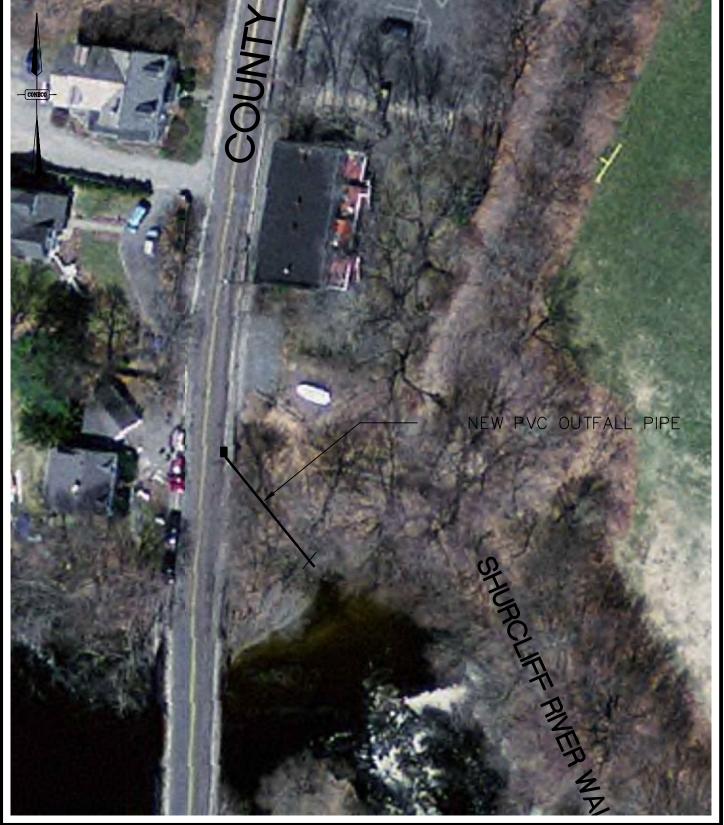
FIGURE # 7

Area 4 is an eroded area at the outlet from the municipal drainage system at the base of the downstream side of the County Street Bridge.

Coastal Resiliency & Coastal Bank Stabilization Pilot Project - Area 4

To improve this area it is recommended that the full length of the existing failed corrugated metal outfall pipe be replaced and that the outfall be extended an estimated 5 feet toward the river to reduce the fall height for water exiting the outfall. It is assumed that the new pipe would be PVC and that it will discharge through a new headwall and onto an improved, stabilized embankment (Figure 7). Coneco has assumed that the headwall and embankment improvements will be addressed by HW in their Task 3 report.
