## Evaluating Aquatic Barriers to Prioritize Restoration

IPSWICH RIVER WATERSHED ASSOCIATION

#### Great Marsh Barrier Assessment

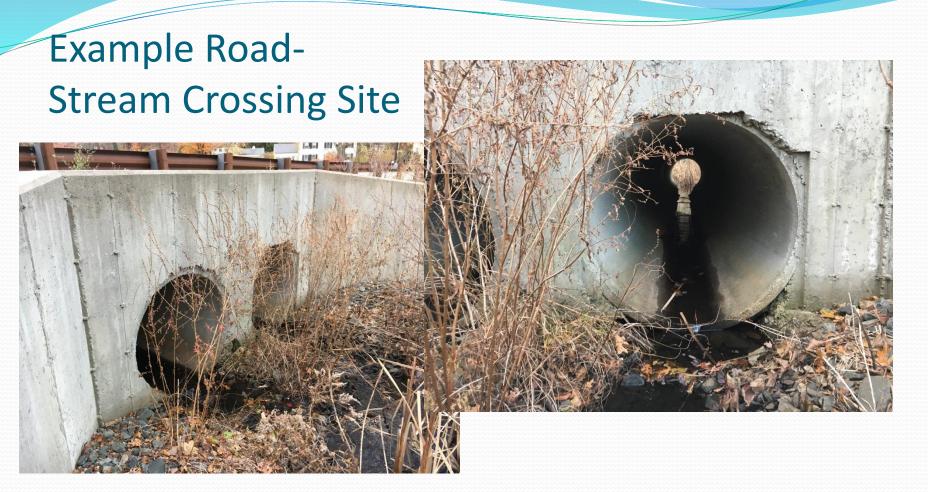
- 2 cell design prone to collect debris
- Not embedded perched outlet prone to scour

- Screening results:
  - NAACC = 0.35/1 (significant barrier)
  - TU HC Screen = Fail @ 50 year storm
  - CP (Combined Priority) Score = 5.4 (Moderate)
