Great Marsh Barriers Assessment

Regional Inventory and Assessment of Risk and Impact of Barriers to Flow in Coastal Watersheds of the North Shore of Massachusetts

February 2018

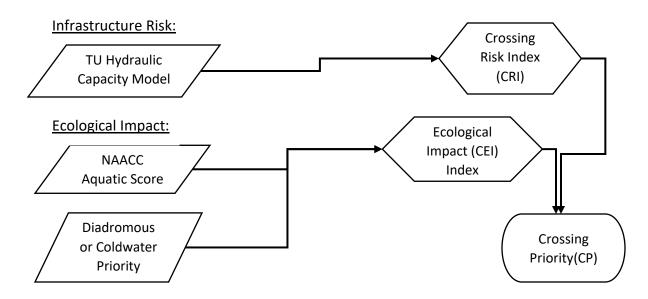
Figure 4. Generalized barrier prioritization scoring process for non-tidal road-stream crossings. Explanations of model inputs and sub-components are fully explained in the Infrastructure Risk, Ecological Impact and Crossing Priority Score sections below.

The CP score, as outlined in Figure 4, is the final numeric value we calculated for prioritizing non-tidal roadstream crossings for upgrade based on our screening of infrastructure risk and ecological impact. The CP score ranges from 0 to 10 with larger numbers representing higher priority structures for replacement. The score is obtained by summing the CRI and CEI scores as follows:

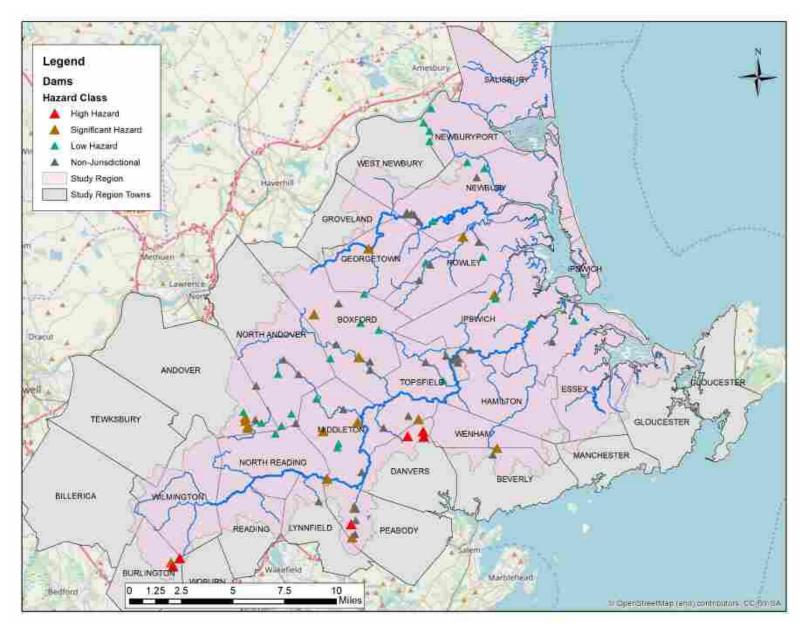
Figure 7. Map of the Great Marsh study region showing dams classified by MA Office of Dam Safety hazard class.

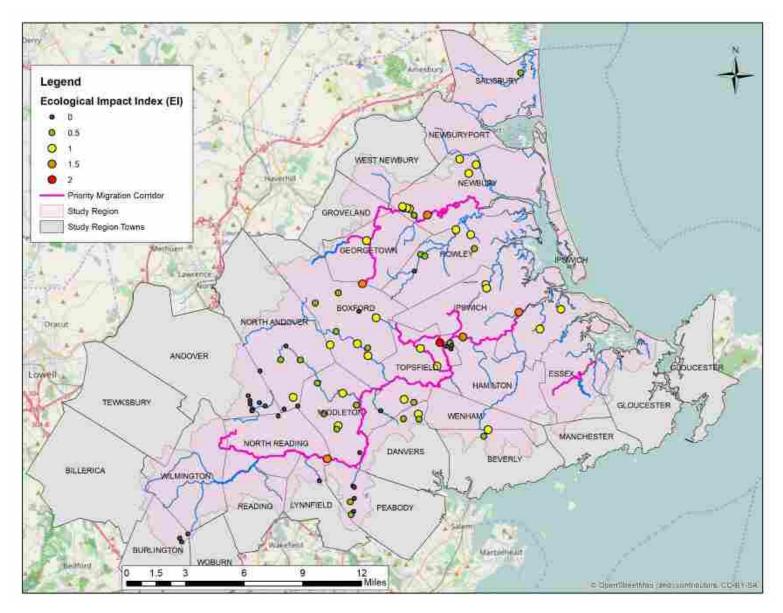
Figure 8. Map of Great Marsh study region showing dams prioritized by Ecological Impact Index scores.

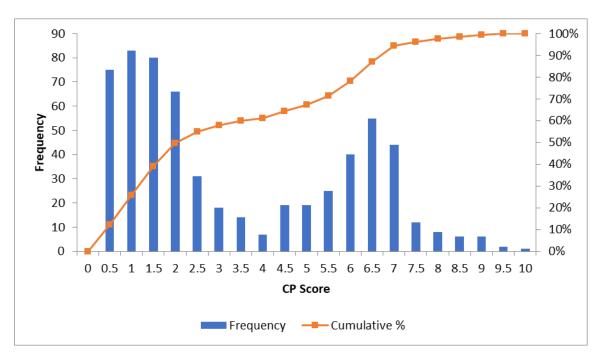
Figure 9. Frequency histogram showing Crossing Priority (CP) scores for non-tidal road-stream crossings in the Great Marsh study region.

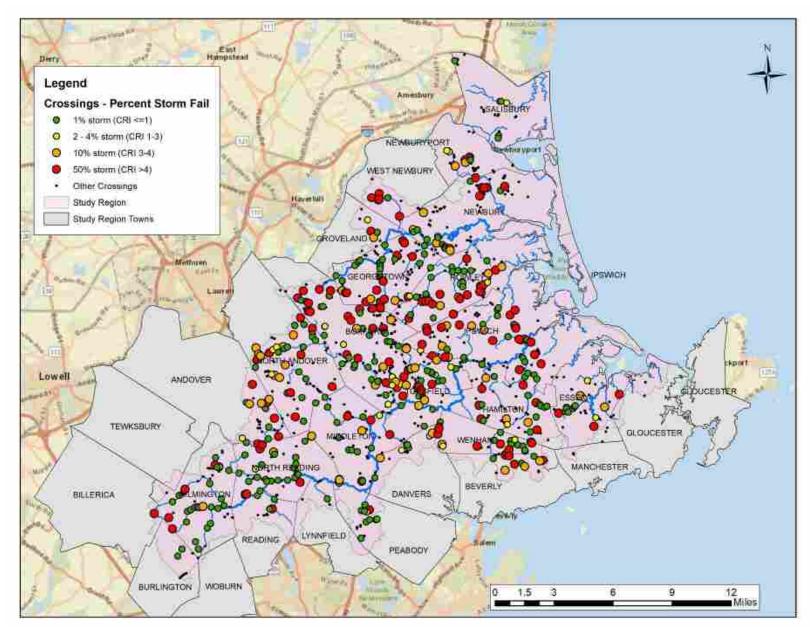
Figure 11. Map of the Great Marsh study region showing non-tidal road-stream prioritized by Crossing Infrastructure Risk Index (CRI) and the percent storm at which it is expected to fail to adequately pass flows.

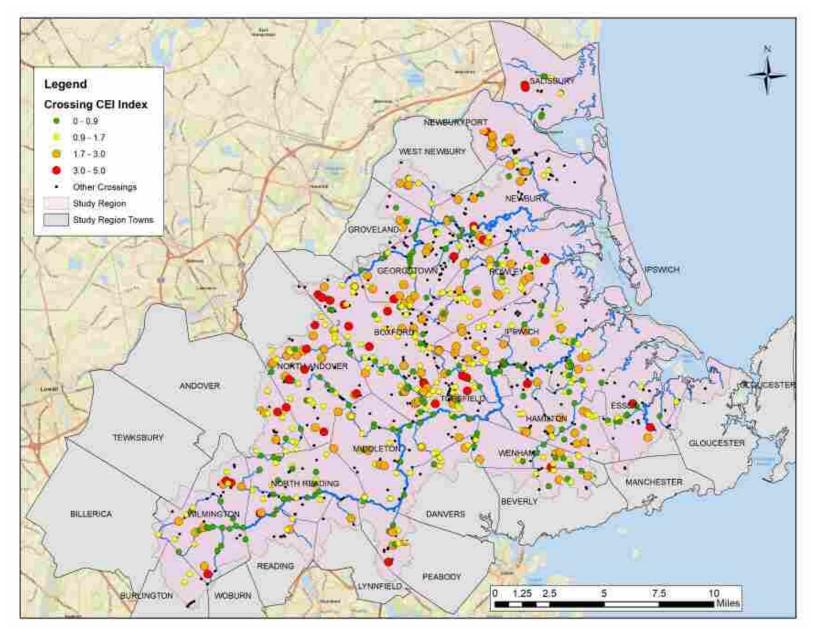
Figure 12. Map of the Great Marsh study region showing non-tidal road-stream crossings prioritized by Crossing Ecological Impact Index (CEI).

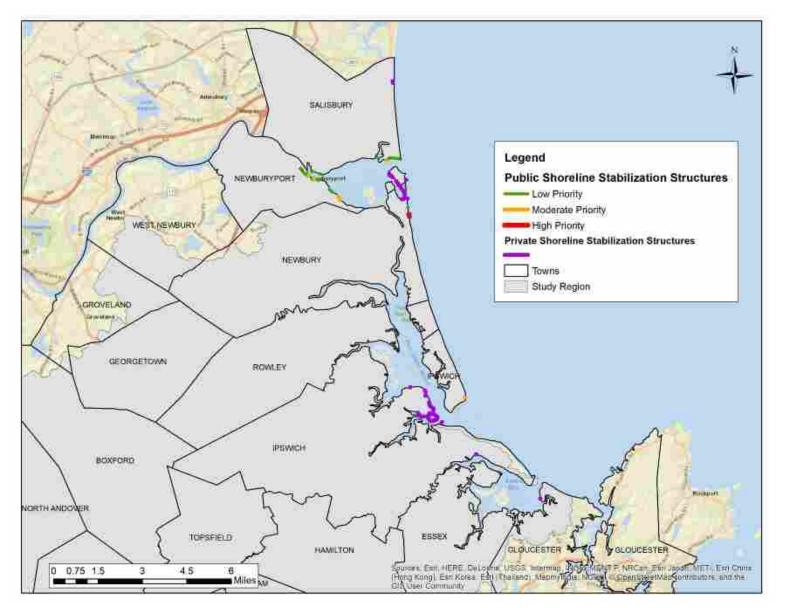
Figure 14. Map of the Great Marsh study region showing prioritized coastal stabilization structures.

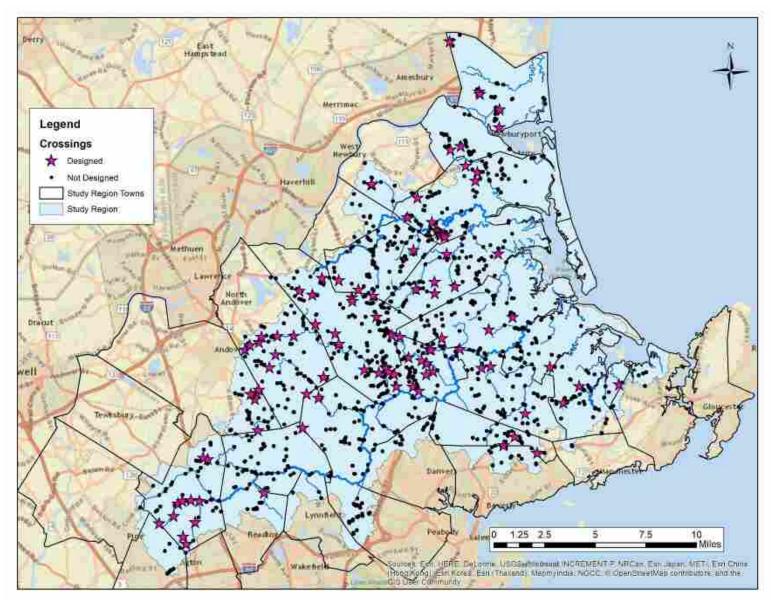
Figure 15. Map of the Great Marsh study region showing crossing sites for which conceptual designs were developed as part of the project.

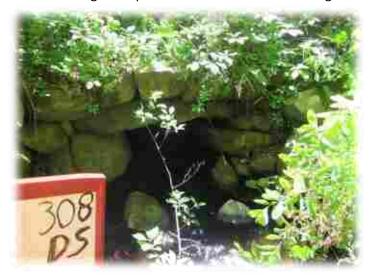
Figure 1. Outlet of non-tidal crossing at Andrews Street in Essex (Site #308).

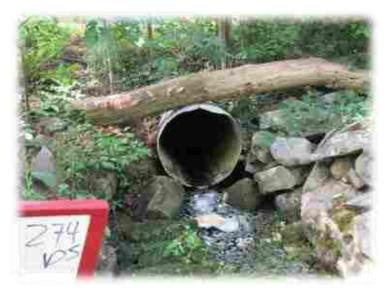
Figure 52. Outlet of road-stream crossing at Forest Street, Middleton (Site #274).

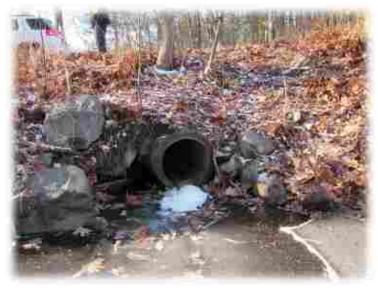
Figure 56. Outlet of road-stream crossing at Liberty Street, North Andover (Site #472).

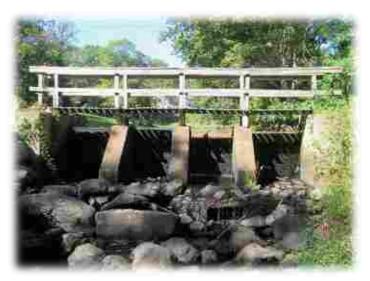
Figure 66. Howletts Brook Dam, Topsfield (MA01610).

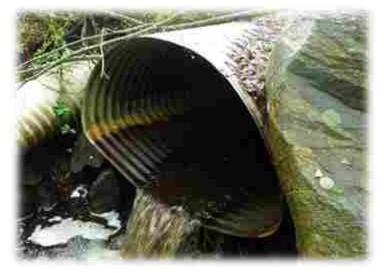
Figure 1. Outlet of road-stream crossing at River Road in Topsfield (Site #435).

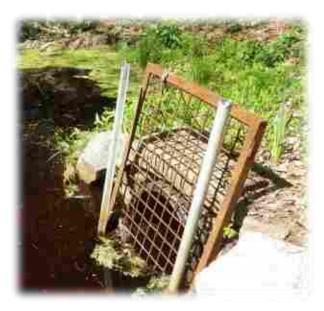
Figure 70. Inlet of road-stream crossing at Hull Street in Wenham (Site #161).
