Feasibility Study for Willowdale Dam Fish Passage Project

Prepared by:
Alden Research Laboratory, Inc.

August 2006

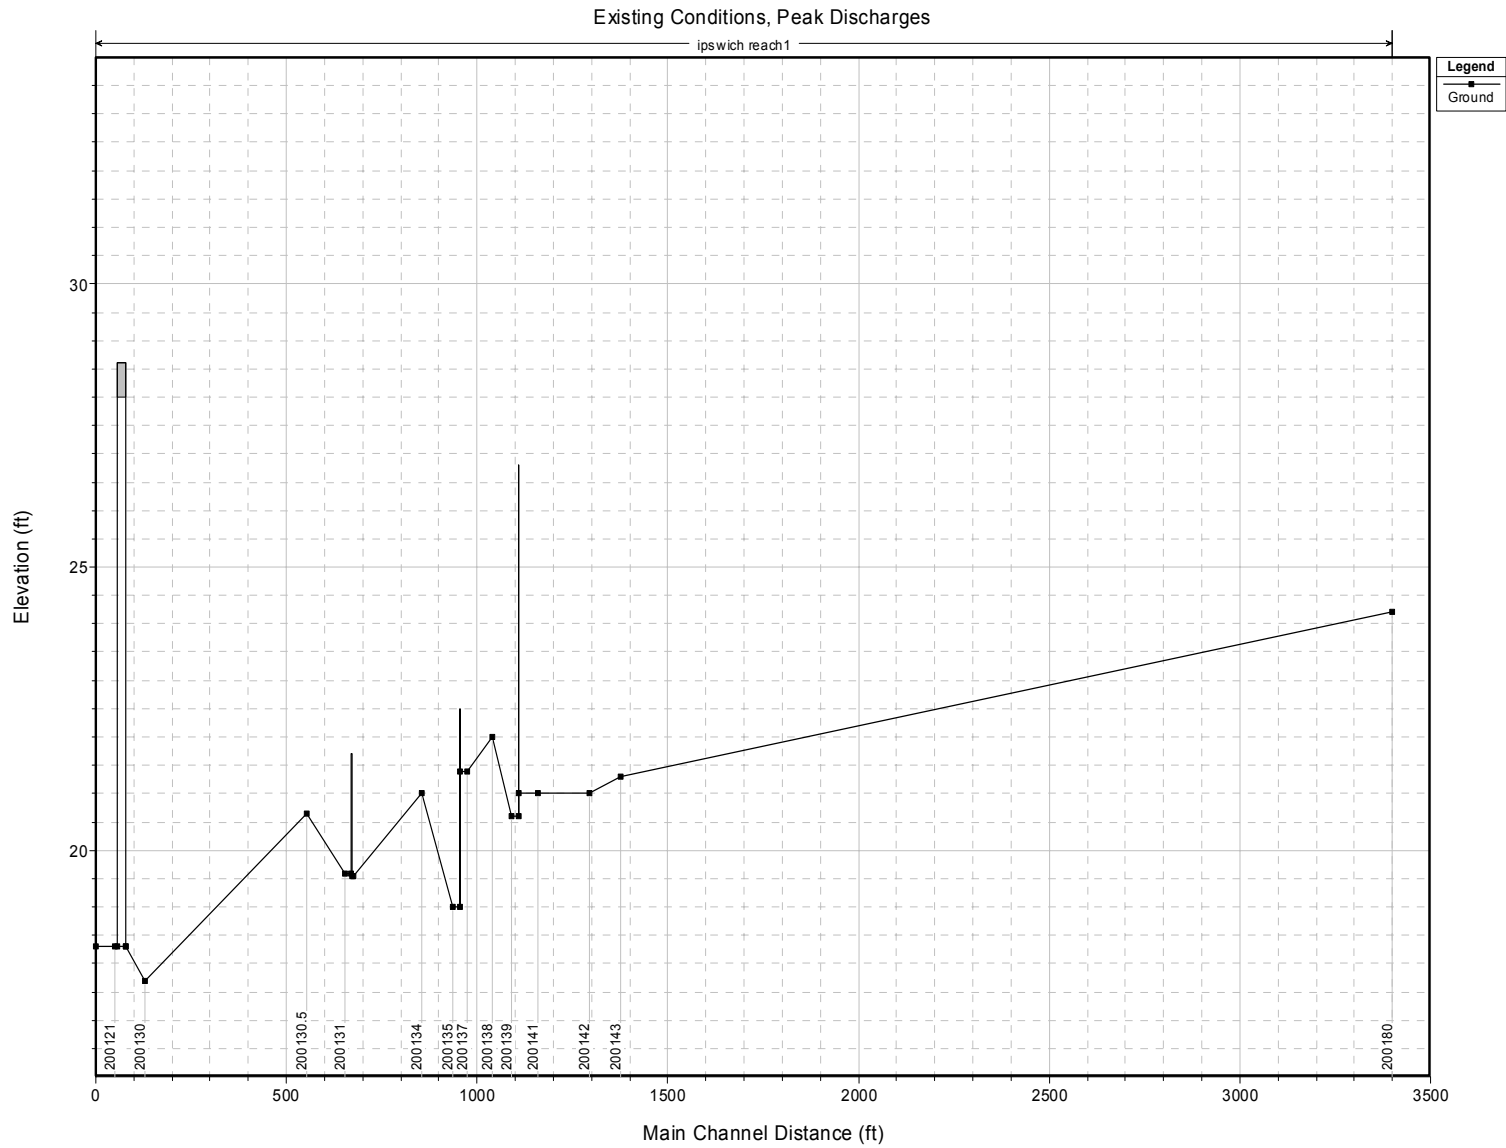
Figure 15 Existing Conditions Centerline Bottom Profile of Ipswich River (see Table 5 for cross section descriptions)

The hydraulic analysis conducted by FEMA was crude, consisting of geometry defined by cross sections spaced roughly every 1,000 ft. Alden used the FEMA geometry data to define the upstream and downstream boundary conditions and the Willowdale Bridge cross section where detailed bathymetry data was not available for the computer model. The upstream boundary location was chosen as the farthest upstream cross section available from the Town of Ipswich FIS hydraulic model data. The Donahoe and Parkhurst bathymetric survey was used to define the conditions immediately upstream and downstream of the dam. A centerline bottom profile of the Ipswich River reach developed for the HEC-RAS analysis is shown on Figure 15 and an isometric view is shown on Figure 16.
