GREAT MARSH BARRIER MITIGATION

A comprehensive program to mitigate aquatic barriers in the Great Marsh Area of Critical Environmental Concern region

TECHNICAL REPORT

Prepared by: Kaitlyn Shaw Ipswich River Watershed Association

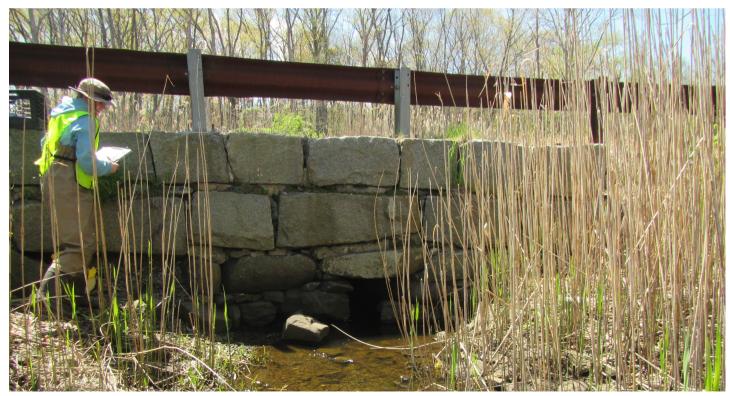
Stream crossing field technician Kristen Thiebeault assesses an undersized stone crossing.

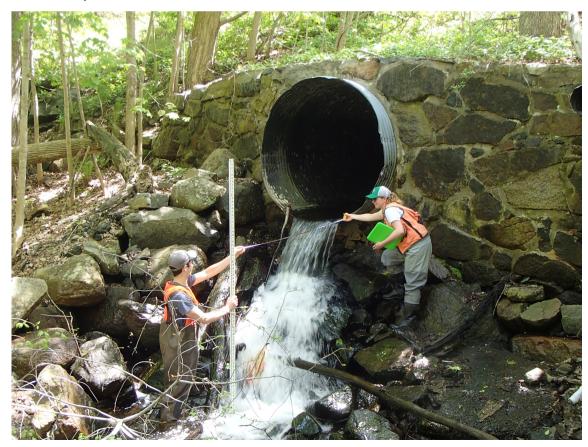
Jacob Lehan of the Division of Ecological Restoration and Kaitlyn Shaw measure the outlet drop of a severely perched culvert in Gloucester.
